TECHNOLOGIC PAPERS

No. 143

A STUDY OF THE DETERIORATION OF NICKEL
SPARK-PLUG ELECTRODES IN SERVICE

HENRY S. RAWDON, Physicist

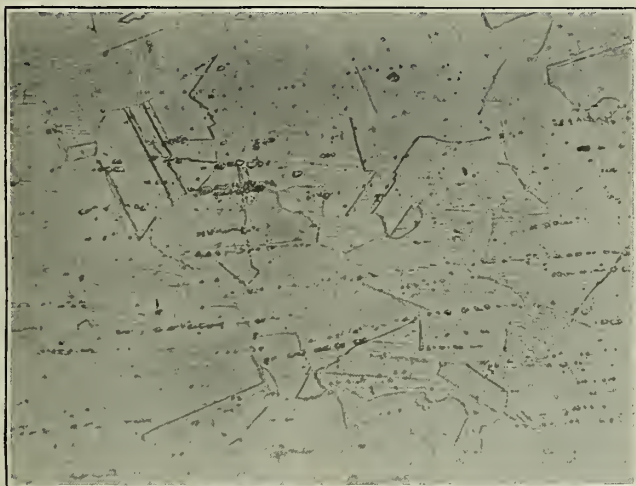
FIG. 4.—Commercial nickel wire: Microstructure of wire of the grade used as spark-plug electrodes

a, Longitudinal section of hard-drawn wire; *b*, longitudinal section of annealed wire; *c*, edge of section shown in *b*, i. e., the surface of the wire

Intercrystalline fissures appear in a very thin surface layer of metal; these have probably formed during the final annealing of the wire

Original magnification, 500 diameters; reduced as indicated in reproduction. Etching, concentrated nitric acid, five seconds

In Fig. 4 is shown the microstructure of commercial nickel wire in the hard-drawn and in the annealed state (specimens 1 and 4, respectively, Table 1). The metal consists of but one type of crystals, as is true with pure metals and solid solutions in general. In the hard cold-drawn wire the crystals show the results of the severe distortion due to the drawing by their elongated form; upon annealing sufficiently a recrystallization takes place and the characteristic appearance shown in Fig. 4, *b*, results. The minute inclusions of oxide and other impurities, which have been arranged in lines parallel to the direction of working during the drawing operation, have been dissolved by the strong etching solution (concentrated nitric acid) which is necessary to develop satisfactorily the crystalline structure of nickel. A definite etching pit marking the location of each inclusion results.

Fig. 4, *c*, shows the outer surface of the annealed nickel wire of Fig. 4, *b*. This wire has received no treatment after the final annealing by the manufacturers. In an extremely thin outer layer a structural change very similar to that which occurs in the nickel electrodes during service has taken place. This undoubtedly occurred during the final annealing; the hard-drawn wires showed

no trace of such a change in the surface metal. In the following discussion (Sec. III) of structural changes produced experimentally in the nickel wire, it should be borne in mind that the extreme surface layer has already been changed to the extent shown in Fig. 4, *c*.

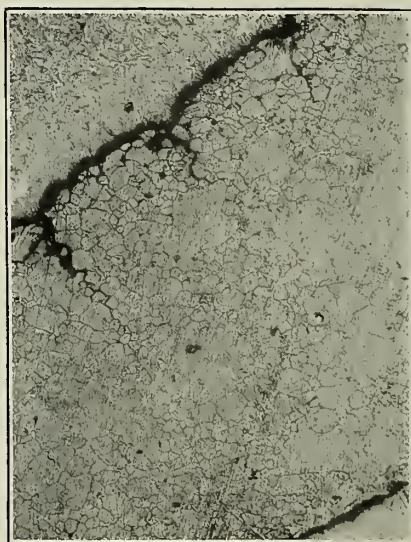
FIG. 5.—Service deterioration of nickel electrodes: Longitudinal sections of side electrodes showing deterioration in service; the arrows indicate the edge of the nickel wire

a, Unetched specimen; *b*, specimen *a* after etching; *c*, unetched specimen; *d*, specimen *c* after etching. Original magnification, 100 diameters; reduced to 72 in reproduction. Etching, concentrated nitric acid, one to two seconds

In Fig. 5 is shown the appearance of longitudinal sections of the side electrode. A series of parallel transverse cracks, some of which extend very deeply into the otherwise sound metal, is apparent in the unetched specimen. By etching with concentrated nitric acid for several seconds, the crystal boundaries of the metal are revealed and the intercrystalline nature of the transverse cracks is made evident. Fig. 6, *a* and *b*, shows the course of one of these cracks at a relatively high magnification.

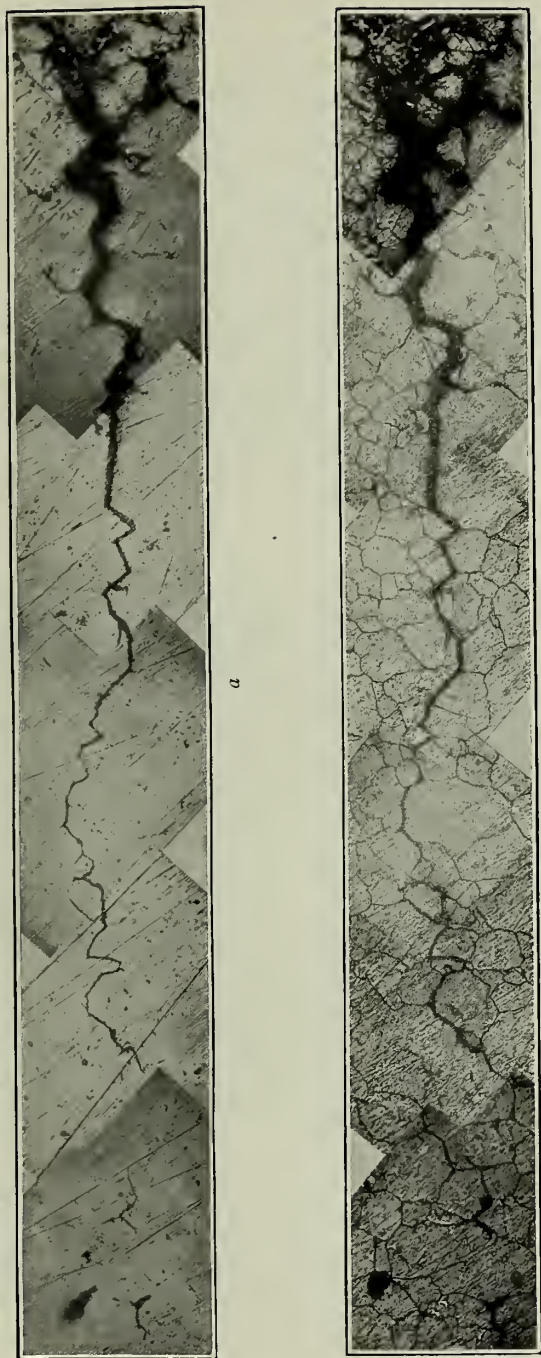
FIG. 6.—Service deterioration of nickel electrodes: Longitudinal section of a side electrode showing one of the transverse cracks of Fig. 5, d
a, Unetched; b, etched, one to two seconds, with concentrated nitric acid
Original magnification, 500 diameters; reduced to 220 diameters in reproduction

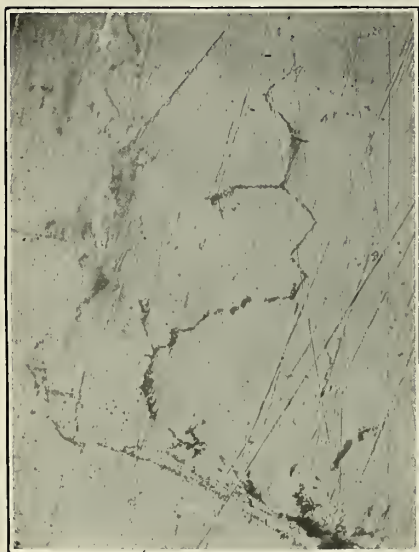
FIG. 7.—Nature of deterioration of nickel electrodes: Longitudinal section through fractured end of wire

a, Section showing the network in the outer zone of the wire and also the intercrystalline fracture. Original magnification, 200 diameters; reduced to 143 in reproduction; *b* and *c* show the lower left-hand corner before and after etching. Original magnification, 500 diameters; reduced to 357 in reproduction. Some of the intercrystalline fissures show a gray nonmetallic substance, evidently oxide. Etching, concentrated nitric acid, one to two seconds

In Fig. 7, *a*, *b*, and *c*, is shown a portion of one of the side electrodes adjacent to the fracture which occurred in this wire. The break was distinctly intercrystalline, as is to be expected from the nature of the transverse cracks. Before etching, many of the intercrystalline fissures are seen to contain a film of gray nonmetallic substance. This is shown in Fig. 7, *b* and *c*. In Fig. 9 the intercrystalline eutecticlike network, seen in the outer portions of the deteriorated wires, is shown. This appears in the unetched specimen.

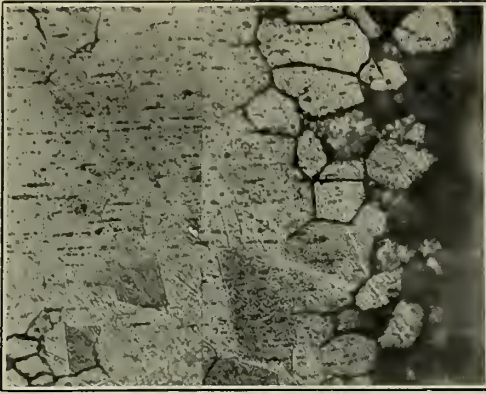
FIG. 8.—*Nature of the fracture of the deteriorated wire: Longitudinal section through the fractured end of a broken electrode*

The path of the fracture is truly intercrystalline; the unchanged sound metal appears just back of the break. Original magnification, 500 diameters; reduced to 263 in reproduction. Etching, concentrated nitric acid, five seconds

Fig. 8 shows a section through the fracture of one of the broken side electrodes and clearly shows the intercrystalline path of the fracture together with some of the sound unchanged metal just back of the face of the break.

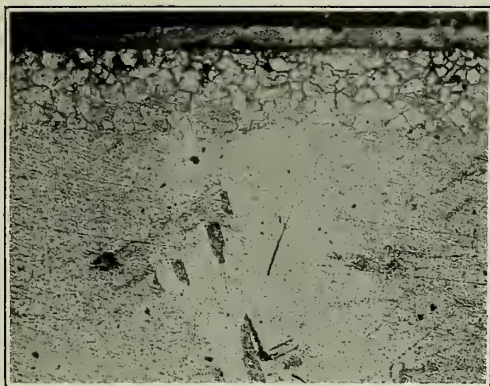
FIG. 14.—*Effect of oxidation upon nickel wires*

Same material as Fig. 12. Etched deeply

a, Original magnification, 100 diameters; reduced to 67 in reproduction; *b*, original magnification, 500 diameters; reduced to 385 in reproduction; *c*, original magnification, 1000 diameters; reduced to 739 in reproduction

The granular eutecticlike network has dissolved, leaving numerous etching pits at the crystal boundaries. Etching, concentrated nitric acid, eight seconds

As the oxidation progresses, the isolated particles of the eutectic coalesce, and a continuous film is formed as is to be seen in the outer portion of the zone of the intercrystalline network (Fig. 13b). In Fig. 14 the same material is shown after deeper etching, and the appearance of the structure is identical with that of the electrodes which have deteriorated in service.
